# **Navajo Abandoned Uranium Mine**

## **Site Screen Report**

**Mine Name: Alyce Tolino No. 1 & 3  
Mine ID: 131**

**August 2011**

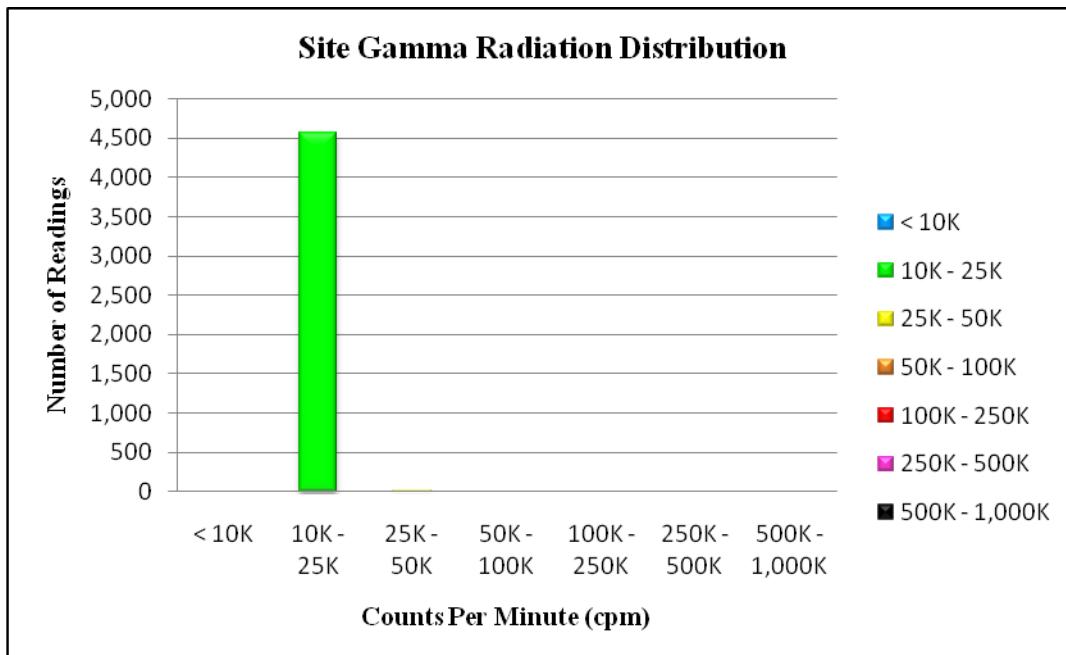
**Highest gamma radiation measurement:** 39,957 counts per minute (cpm)

<b>Site Gamma Radiation Statistics</b>	
Number of Readings	4,568
Minimum (cpm)	10,568
Maximum (cpm)	39,957
Mean (cpm)	14,659
Median (cpm)	14,272
Standard Deviation	2,039

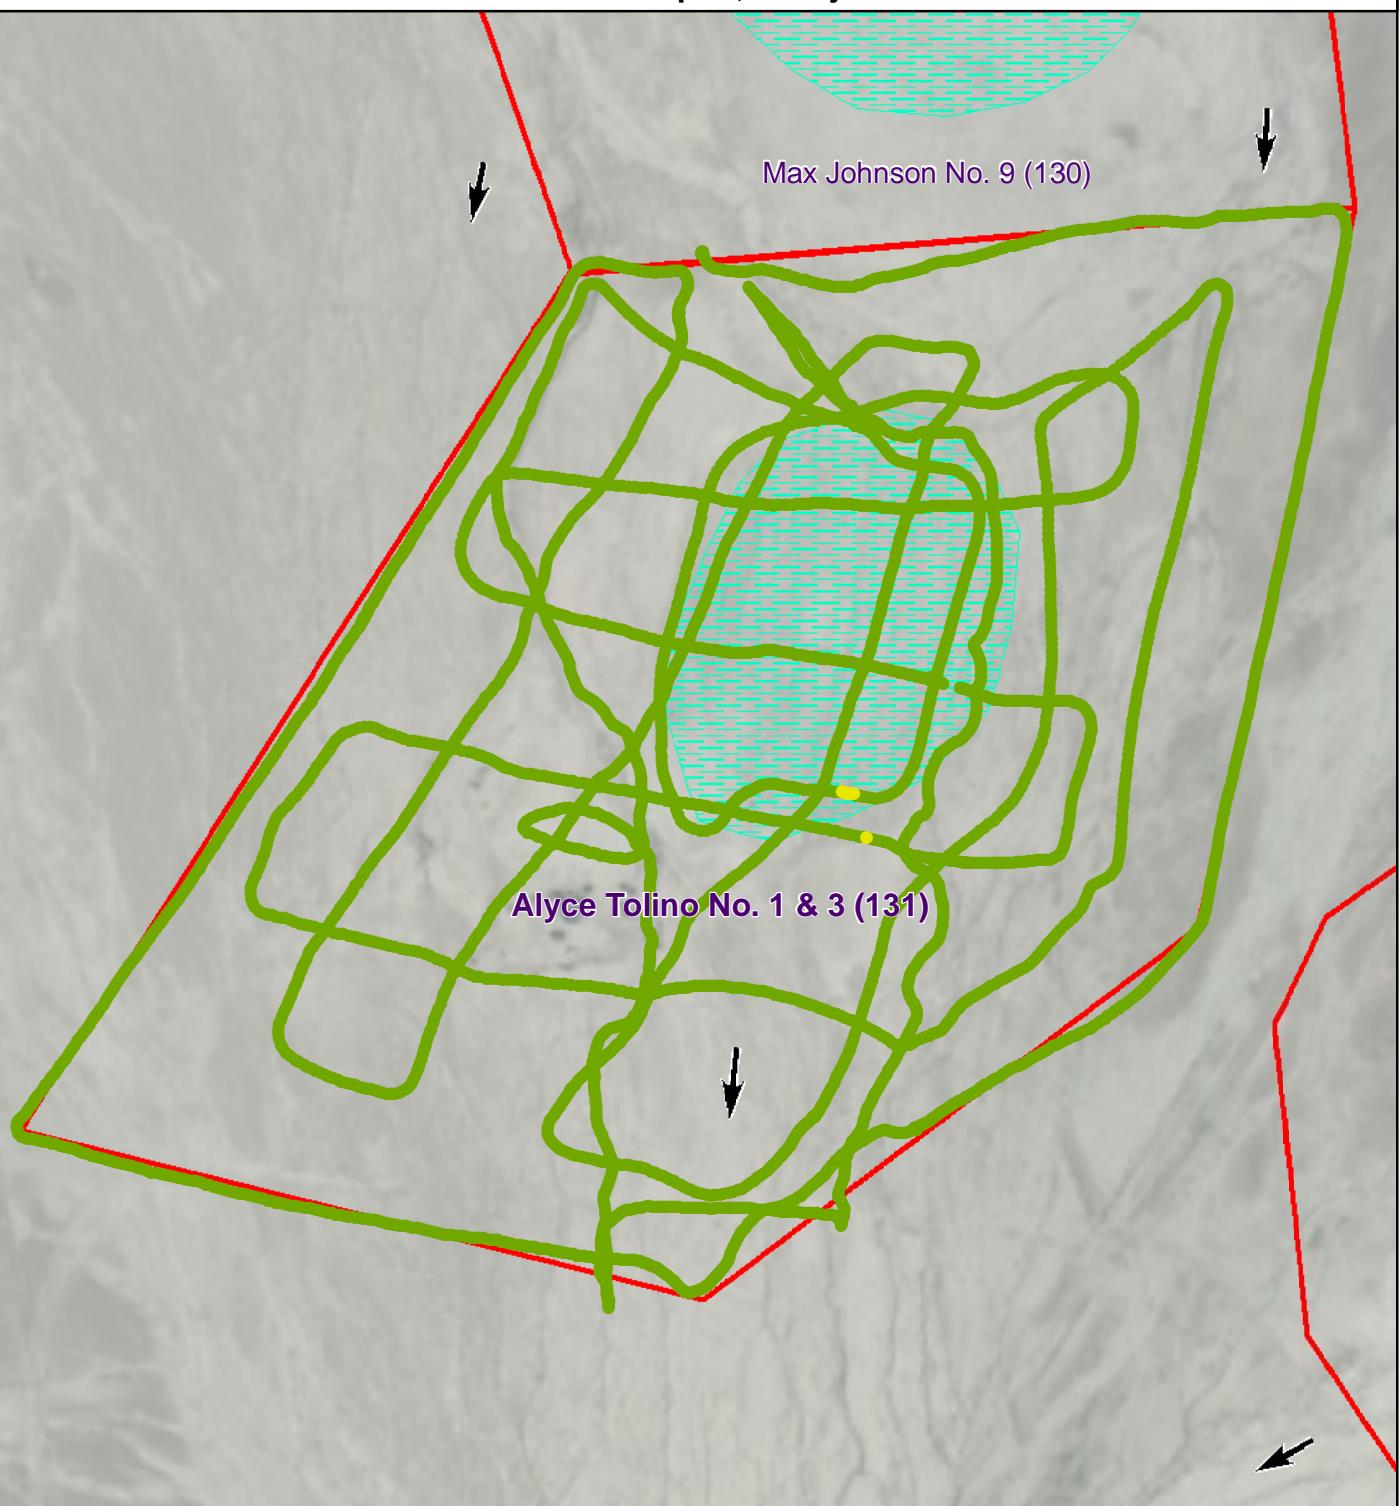
**Figure 1 - Gamma Radiation Measurements, Above Two Times Background**  
**Alyce Tolino No. 1 & 3 (131)**  
**Coalmine Mesa Chapter, Navajo Nation**

**Background Average:** 13,535 cpm        **Two Times Background:** 27,070 cpm

A total of 4,568 gamma radiation measurements were collected from the mine site, ranging from 10,568 cpm to 39,957 cpm. The measurements are represented in Figures 1 and 2.
